Title: Linthicum Community Sign – Progress Report #04

By: Dan Woomer

News from our secret restoration facility “DWG.”

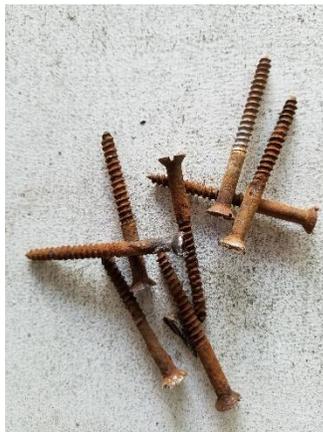
The existing battens holding the sign planks together were removed by breaking them in half. All of the battens are deeply rotted and broke apart easily. The wood rot present allowed water to penetrate into the batten causing deep corrosion of the zinc plated steel screws holding the battens and sign planks together.

Virtually all of the flat blade wood screws were so weakened by the rust, the heads stripped with each attempt to remove them. Breaking the battens apart allowed the careful removal of the screws employing pliers and vice grips. Luckily only one screw sheared off. The residual part of the screw was ground down flush to the back side of the plank.

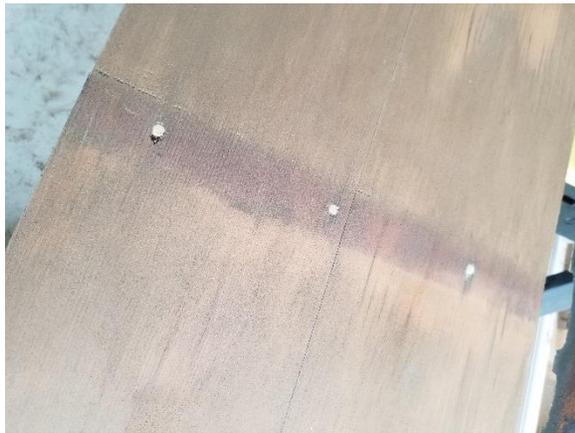
All of the screw holes in the planks holding the original battens in place show signs of minor water penetration and decay. Each of these holes were drilled out employing a 1/4" diameter forstner bit.

Each hole was vacuumed out, then a 1/4" poplar diameter dowel was glued and hammered into the hole then trimmed off flush with the surface of the plank. Employing dowel plugs, glue, and where needed, an exterior rated wood filler, the original screw holes will be sealed. Once the glue cured, the plugs were sanded off smooth to the back surface of the planks. Any remaining voids will be filled and sanded once the sign is reassembled.

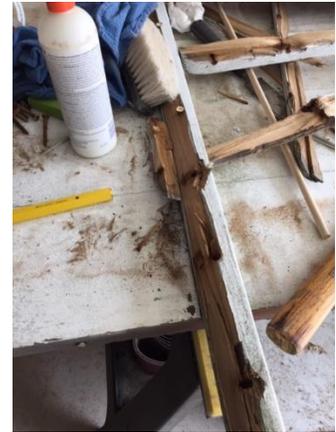
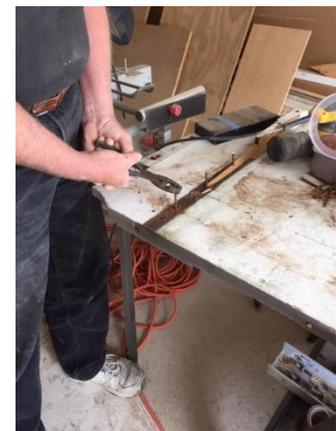
another continued. Planks #6 and #7 came apart from plank #5. Planks #6 and #7 appear to be glued together, so the attempt to separate these planks from one another was stopped. Also, planks #3 and #4 also appeared to be glued together so again the attempt to separate these planks from one another stopped. These two sections of the sign will be cleaned as if they are one piece.

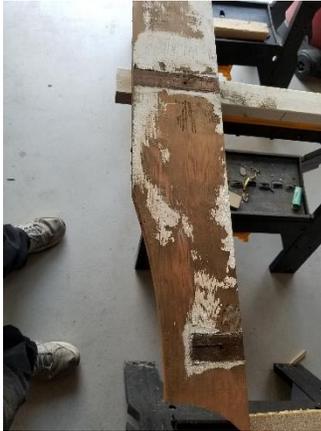
The back of plank #2, disassembled from the sign, shows the initial belt sanding and the marks where the original battens were located. The residual finish was belt sanded off and the plank was smoothed with a random orbital sander. The sign frame portion of this plank was also belt sanded, and finished with a random orbital sander. Now begins the slow removal of the sign's background finish employing hand chisels. As seen in the photo to the right, Suzzie Schuyler is engaged in the tedious work to carefully hand chisel off the rough background finish and partly rotted wood off of the sign.

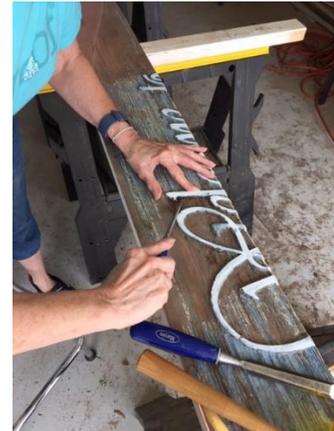
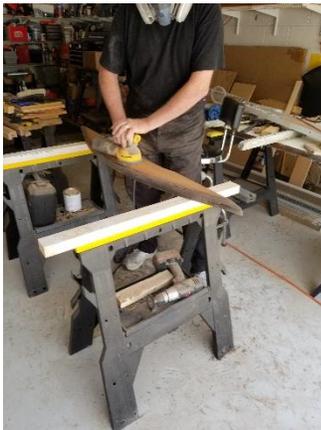
As seen in the photo to the left, Dan Woomer is sanding off plank #1. This first and smallest plank is now cleaned. The next task for this plank will be to mortise out the large area of rot that has penetrated from the top edge of the sign, through Plank #1 and well into plank #2.

The 2nd batten is unclamped and finish sanded. Now ready for final sizing and finishing. There will be a total of five (5) new battens made from red oak that will be glued up and sanded in the same manner as battens #1 and #2. As seen in the photo to the right the red oak boards are now glued and clamped together to form the 3rd batten. Also seen is plank #1 now stripped, sanded and waiting for the rotted area to be mortised out and repaired.

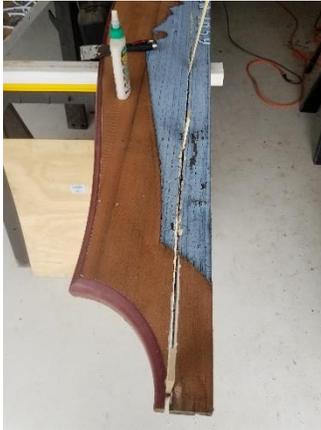
As the sign planks were being disassembled, plank #6 was found to be cracked and split nearly one-half of its length. To repair this, Dan carefully inserted wood shims to separate the split and injected wood glue into the split. The glue was worked onto the split surfaces with a 2" flat blade putty knife. Once all of the surface area on the two sides of the split was covered with wood glue, plank #6 was clamped to close and bond the split together.

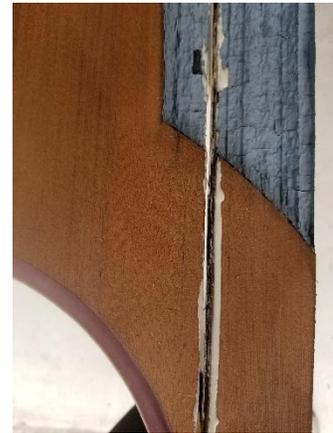
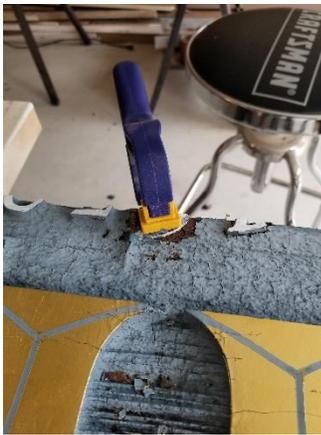
As the chiseling of the original and now failed finish continues, and the areas where the underlying rotted red is removed, several areas of the raised lettering were found to have rot and needed to be stabilized, repaired or rebuilt. Each small bit of the damaged lettering was carefully cleaned then repaired, with each repair being allowed to sit for 24 to 48 hours to make sure the glue or wood filler had ample time to fully cure.

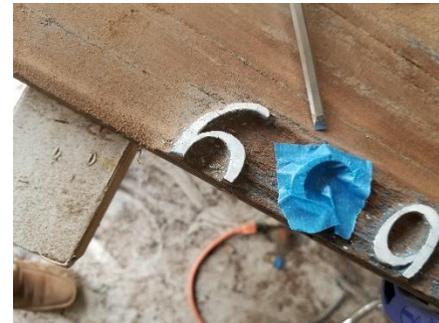
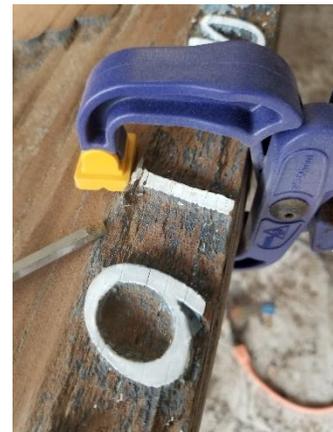
Looking closely at the photo above and to the left. Note the rough background surface behind the lettering. Look closely at the area between to two gold colored letters. Note the dark areas where the underlying red wood was exposed to the weather. This is rot. Also see how the original finish has cracked apart into small pieces. All of this failed finish and wood rot will be removed.

Now look at the photo to the right and again note the background behind the lettering now that most of the original finish is removed. The gray color on the surface of the red wood is rot. All of this rot will be removed, mostly by hand, to expose the sound red wood underneath. Also, the entire background behind the lettering will be smoothed to enhance the restored sign's water runoff and reduce moisture collection. All of this work to further extend the sign's life.

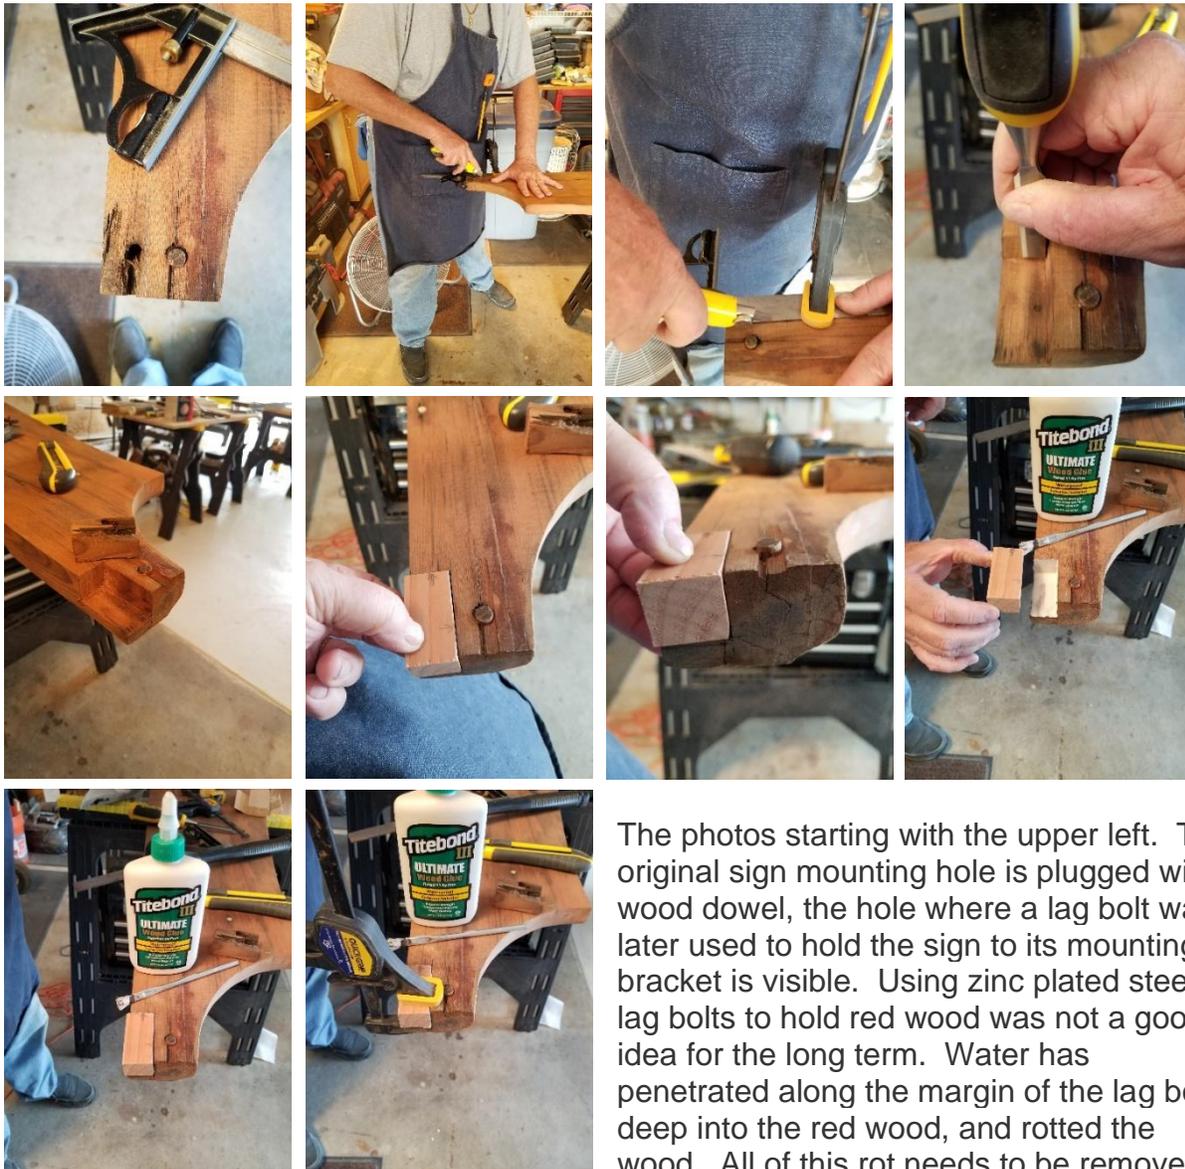
The back side left and right edges of the sign had several areas where the red wood was broken out and water had wicked into the end grain, penetrating deep into the wood rotting larger areas of the sign's planks. The following series of photos shows how each of the larger areas of damaged were mortised out until sound red wood was found, and a new piece of red wood was fitted, glued and clamped into the mortised area. Over the next few months, Dan Woomer will repeat this process again and again until all of the sign's planks are made whole.

The photos starting with the upper left. The original sign mounting hole is plugged with wood dowel, the hole where a lag bolt was later used to hold the sign to its mounting bracket is visible. Using zinc plated steel lag bolts to hold red wood was not a good idea for the long term. Water has penetrated along the margin of the lag bolt, deep into the red wood, and rotted the wood. All of this rot needs to be removed.

Dan Woomer lays out the area to be mortised. The clamp is holding a guide to cut a straight line into the plank. That straight cut is used to align the wood chisel to begin the mortising (removal of the rotted wood). With the rot mortised out of the plank, a new piece of red wood is cut and shaped. The new piece of red wood is fitted, shaped, fitted, and shaped repeatedly until it fits tight into the mortised area. Once a tight fit is

achieved, the new piece of red wood is glued in place and clamped. The clamp will stay in place for at least 24 hours to allow the glue to fully cure.

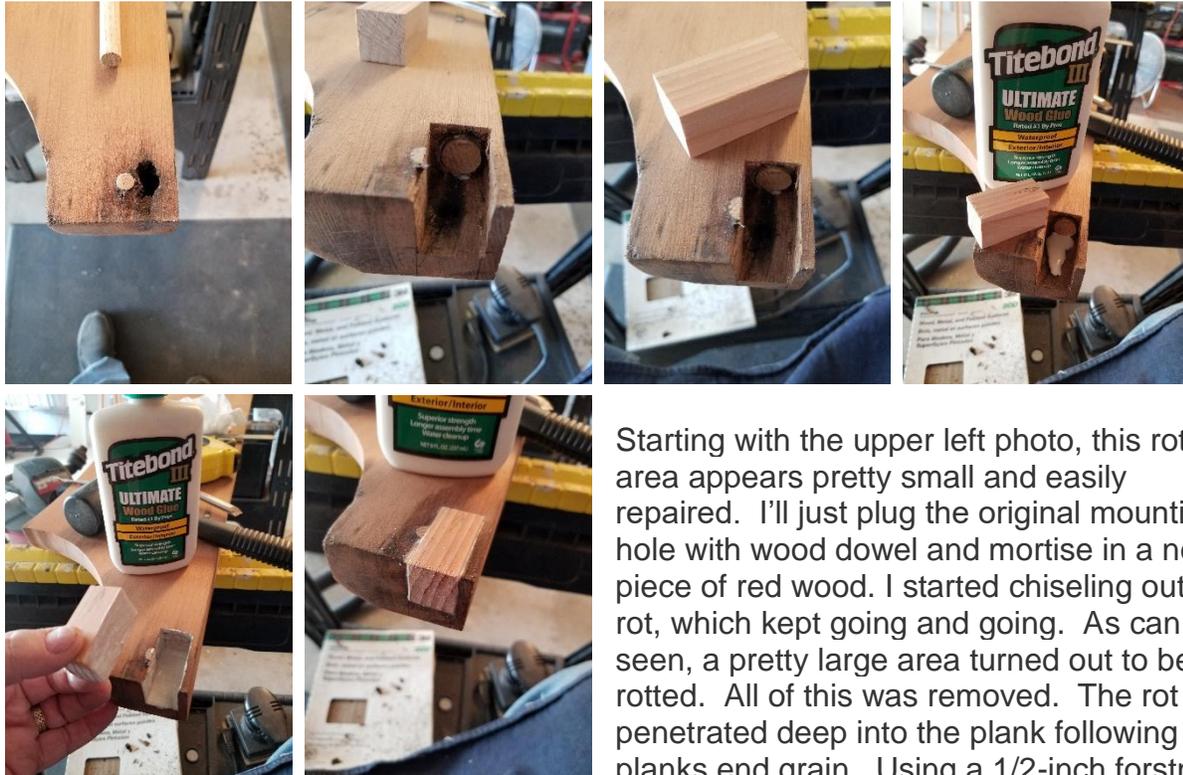
The following series of photos show what appeared to be a minor amount of wood rot that again penetrated into the sign plank along the edges of a lag bolt. As you can see, the appearance was deceiving. Rot penetrated deep into the plank as water wicked into the end grain of the plank.

Starting with the upper left photo, this rotted area appears pretty small and easily repaired. I'll just plug the original mounting hole with wood dowel and mortise in a new piece of red wood. I started chiseling out the rot, which kept going and going. As can be seen, a pretty large area turned out to be rotted. All of this was removed. The rot penetrated deep into the plank following the plank's end grain. Using a 1/2-inch forstner bit, the rot was drilled out and a 1/2-inch dowel was glued and driven into the hole, then trimmed off flush to the rear face of the mortise. A new piece of red wood was shaped, fitted, glued and clamped into place. Again, this clamped up repair sat for over 24 hours to allow the glue to fully cure.

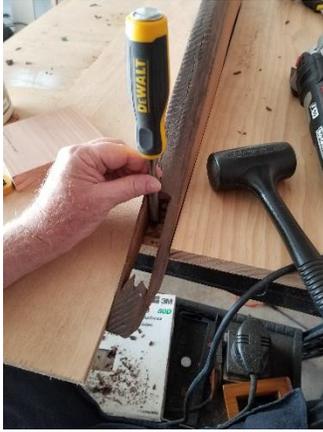
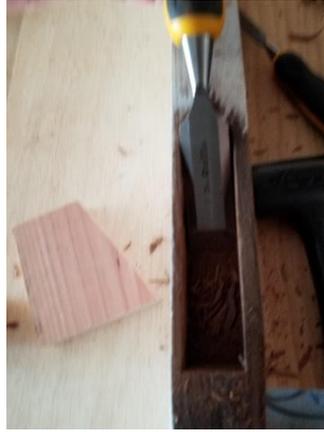
Now for the most challenging repair. In the prior Progress Reports, the large rotted area that went through the top edge of the top plank and into the second plank was called out. Now came the time to make these repairs. The rotted wood not only extends through the top plank, but nearly to the outer edges of the rear and face sides of the plank. The rotted wood was very slowly and carefully removed.

As can be seen in the far-left photo, by the time the rotted wood was removed from the top plank of the sign, there wasn't much left of the original wood plank. Note how thin the remaining wood is on the rear and front faces. The next photo shows how deep the wood rot penetrated into the top edge of the second sign plank. Again, note how thin the wood is on the rear and face sides of the plank.
