Title: Linthicum Community Sign – Progress Report #04

By: Dan Woomer

News from our secret restoration facility “DWG.”

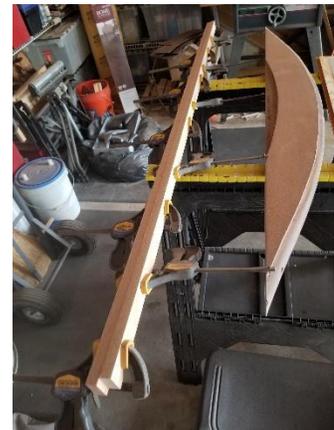
As seen in the photo to the left, Dan Woomer is sanding off plank #1. This first and smallest plank is now cleaned. The next task for this plank will be to mortise out the large area of rot that has penetrated from the top edge of the sign, through Plank #1 and well into plank #2.

The 2nd batten is unclamped and finish sanded. Now ready for final sizing and finishing. There will be a total of five (5) new battens made from red oak that will be glued up and sanded in the same manner as battens #1 and #2. As seen in the photo to the right the red oak boards are now glued and clamped together to form the 3rd batten. Also seen is plank #1 now stripped, sanded and waiting for the rotted area to be mortised out and repaired.
